Update on the occurrence of the soil liquefaction phenomenon in peru
Actualización de la ocurrencia del fenómeno de licuación de suelos en el Perú

Jorge Alva-Hurtado¹0000-0001-9107-2218

Carmen Ortiz-Salas^{1*}0000-0002-7643-6711

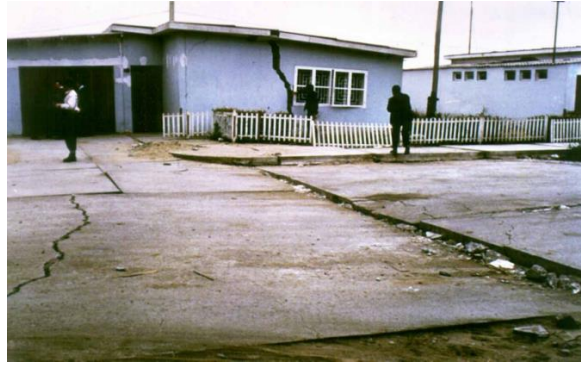
The largest areas of sand boils formed along the Casma river, between Casma and the Port of Casma. The central crater of the volcanoes measured from several centimeters to 1 m in diameter, surrounded by a mound of sand and silt of up to 15 m in diameter. There were also jets of water reaching a height of up to 1 m. Soil liquefaction was evident in Chimbote's central area, as was the differential compaction of the foundation. The Casma bridge was damaged due to the liquefaction of the foundation of the abutments. Liquefaction-induced ground subsidence could be observed in Chimbote, Casma and along the Pan-American Highway. The residential area of the Port of Casma showed evidence of settlement and water ejection. Cluff [14] reports ground failure in Chimbote due to saturated and loose beach deposits. Liquefaction-induced lateral spreading and differential compaction also occurred in Casma (Fig. 1).

Fig. 1. Concrete-block house affected by differential compaction and lateral spreading due to the liquefaction of beach sand.

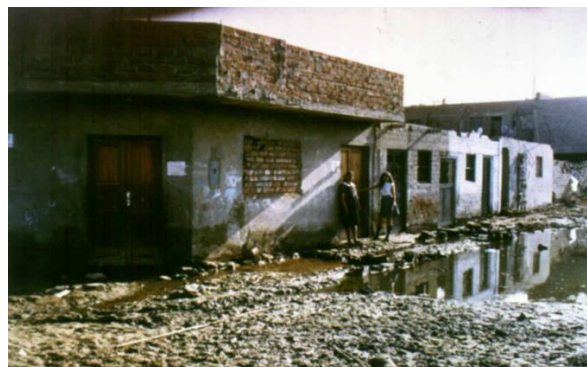
Differential compaction caused the land to be flooded by groundwater (Fig. 2). Sand boils and water ejections appeared in many areas because of the high-water table. Berg and Husid [21] report evidence of soil liquefaction in the foundation of the Mundo Mejor school in Chimbote. Carrillo [22] points to the settlement of the access embankments of almost all the bridges along the Pan-American Highway, as well as settlement of the platforms of the Chimbote Port Terminal. There was also evidence of the liquefaction phenomenon in saturated sand deposits along Elias Aguirre street in Chimbote and along km 380 of the Pan-American Highway, near Samanco.

Fig. 2. Flooding of area in southeast Chimbote due to settlement and soil compaction.

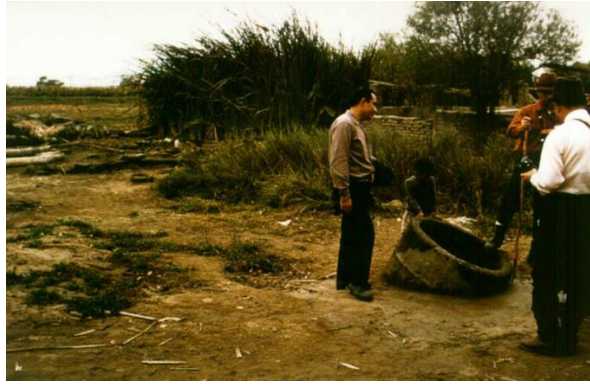
Fig. 3. Damage to sewer inlets due to liquefaction

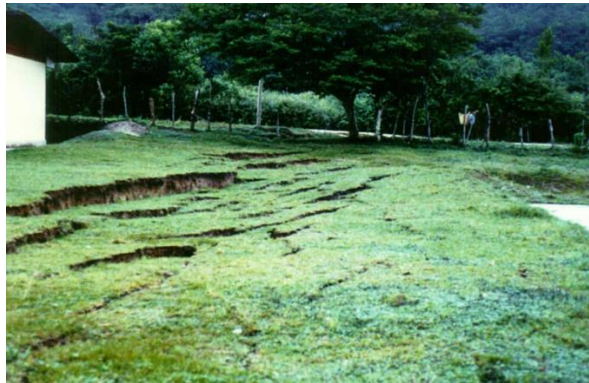
Alva [32] observes and describes the soil liquefaction phenomenon at the Port of Tahuishco in Moyobamba. Lateral spreading due to liquefaction occurred at the Educational Center of Tahuishco in 1991, creating cracks 10 cm wide and 50 cm deep (Fig. 4). The floor of a classroom was destroyed. During the 1990 earthquake, the phenomenon did not reach the school building, but it did reach its courtyard where sand boils appeared.

Fig. 4. Ground cracking near the Tahuishco school due to soil liquefaction

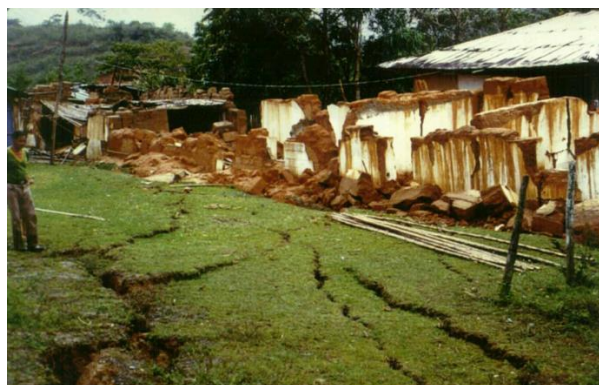
Ground cracking and lateral spreading occurred in Azunge, located in the Moyobamba lowlands. Cracks were reportedly 100 m long, 40 cm wide and 1 m deep. Most of the houses on the slopes collapsed. The pumping station and sewer lines failed. All the mudwall houses and a few brick houses built on soft ground collapsed (Fig. 5).

Fig. 5. Damage to mudwall houses and ground cracking due to lateral spreading in Azunge.

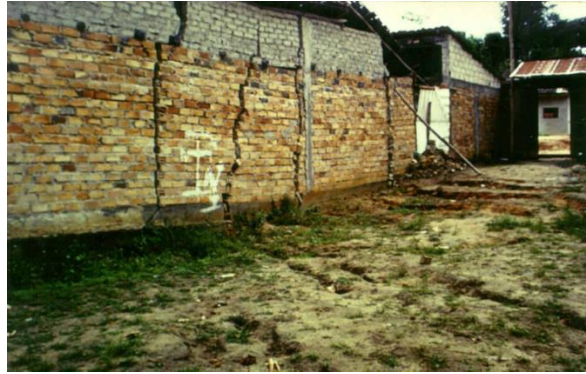
In Shango, mudwall houses collapsed. 80-cm-long cracks with a 20 cm slope were observed (Fig. 6). Along Miraflores street, cracks were 30 m long and had a depth of 30 cm.

Fig. 6. Ground cracking due to liquefaction going through a brick wall in Shango

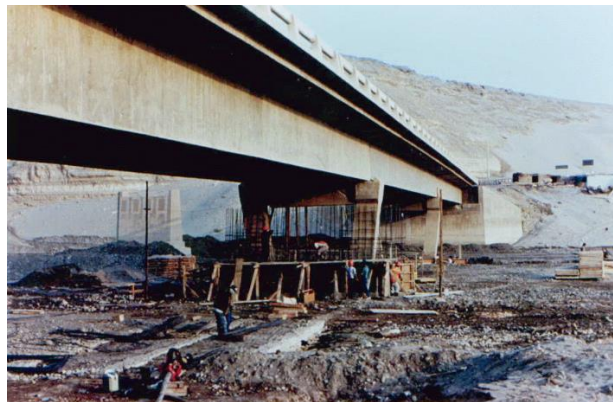
Alva and Vasquez [33] indicate that soil liquefaction occurred along the riverbed of the Yauca river, as did sand boils, mud ejections and cracking. Cracks opened on the top beam and column of one of the bridge's pillars, and the board was displaced. Traffic was interrupted and bridge repair and restoration works began immediately (Fig. 7).

Fig. 7. Soil liquefaction in the foundation of the Yauca Bridge

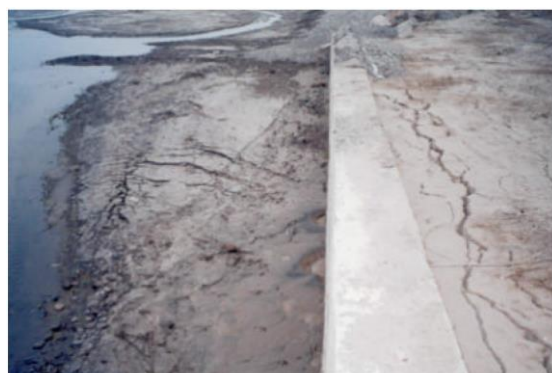
Fig. 8. Containment wall pulled into the abutment of the bridge over the Sama river

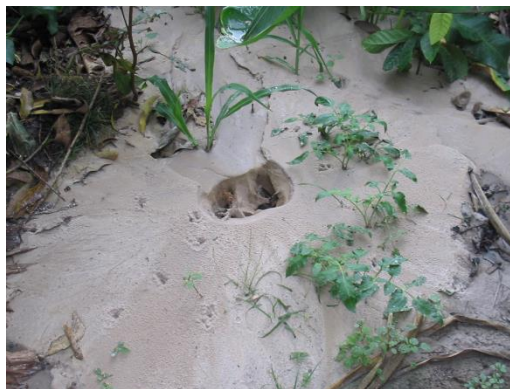
Fig. 9. Sand boils, city of Moyobamba

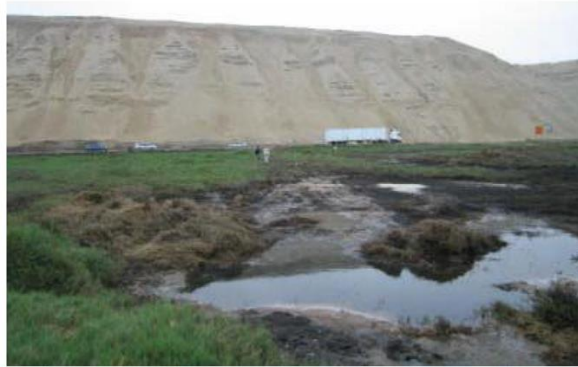
Slope failure in Jahuay: The 400-m long, liquefaction-induced failure in Jahuay occurred at the foot of a steep slope, approximately 30 to 50 m in height. It occurred near kilometer 188 of the Pan-American Highway (Fig. 10), just south of the toll booth (approximately 40 km from the rupture plane). Sand cones were found on either side of the highway and a person living just south of where the landslide occurred reported large quantities of water and sand ejecting from the ground during the earthquake, reaching heights of up to 1 m. A sand cone found at the southern tip of the slope failure had contraction cracks in the perimeter material, indicating the presence of fine plastic (Fig. 11).

Fig. 10. 400-m slope failure along the Pan-American Highway

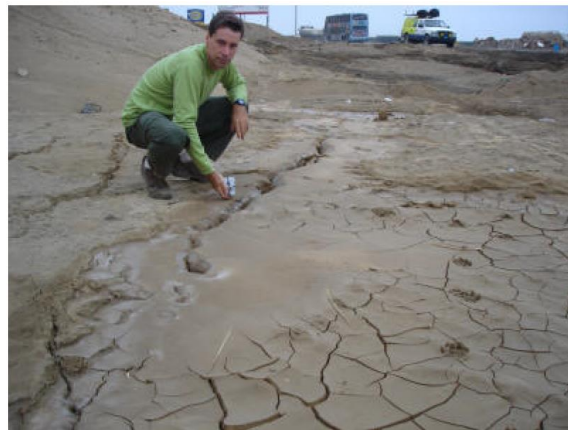
Fig. 11. Large sand cone with possibly liquefied fine grains.

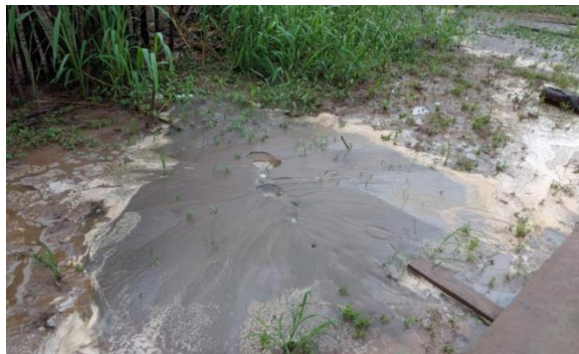
There were problems given the soil liquefaction phenomenon, with evidence of sand cones and lateral spreading with cracks along the Huallaga river pier (Fig. 12), at the "El Sauce" Resort (Fig. 13), in the town of Tamarate (Fig. 14), near the Lagunas district and in the 2 de Mayo hamlet in San Martín, Rengifo [40].

Fig. 12. Sand cones found along the pier of the Huallaga river, in the district of Lagunas, province of Alto Amazonas, Loreto.

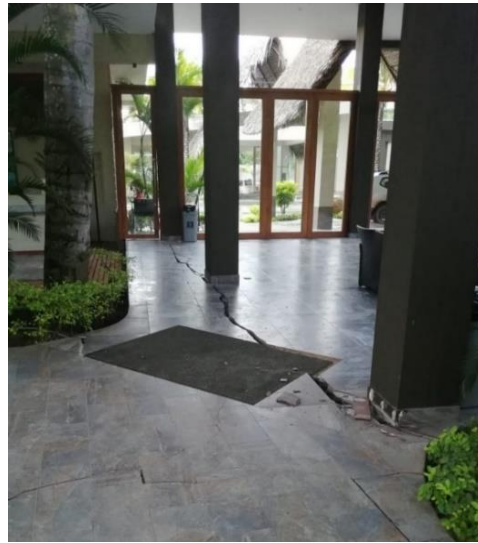
Fig. 13. Lateral spreading with cracks at the “El Sauce” Resort in Tarapoto
