Diagnóstico, plan de tratamiento y restauración de un diente con el síndrome del diente fisurado: reporte de caso y seguimiento de siete años

Diagnosis, planning, and restoring treatment of cracked syndrome tooth: case report - 7-year follow-up

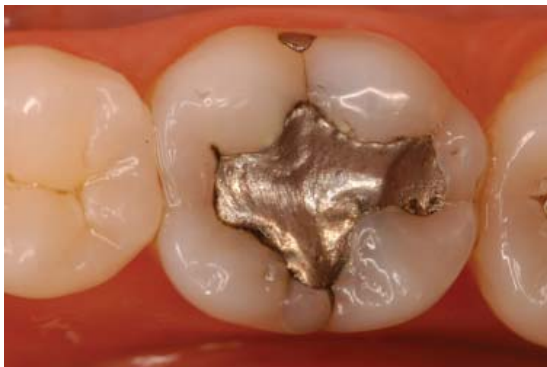
Clinical examination revealed two Class I amalgam restorations in mandibular first molar, one in the central sulcus and the other in the buccal sulcus (Figures 1 and 2). They appeared to be secondary carious lesions and were classified as clinically unsatisfactory. According to the patient, sensitivity to hot and cold had started five months before and the restoration was made 18 years earlier. There were two pigmented cracks, one on the buccal (Figures 1 and 2) and the other on the lingual surface. Occlusal contacts were checked with articulating paper and revealed a larger contact area on the occlusal surface than in other areas. Periapical and interproximal radiographs did not suggest the presence of a crack (Figure 3). Was performed tooth percussion and pulp vitality test with cold air and the patient responded with sensitivity.

Figure 1. Initial occlusal view.

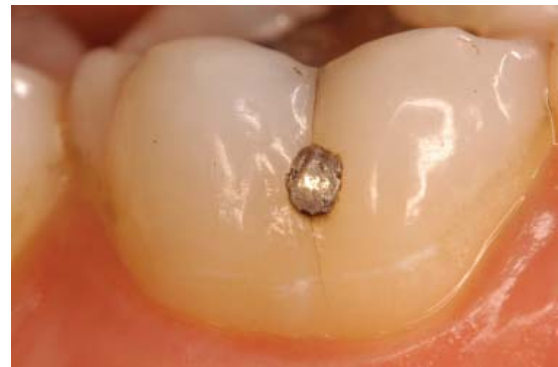
Figure 2. Initial buccal view.

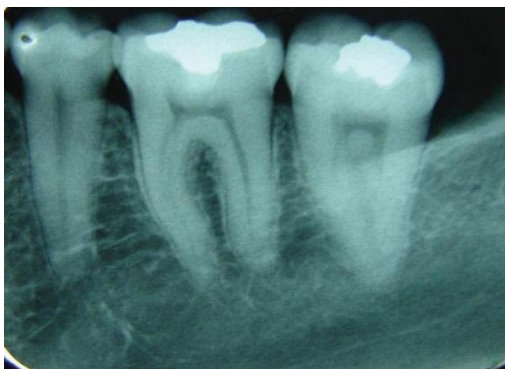
Figure 3. Baseline radiograph.

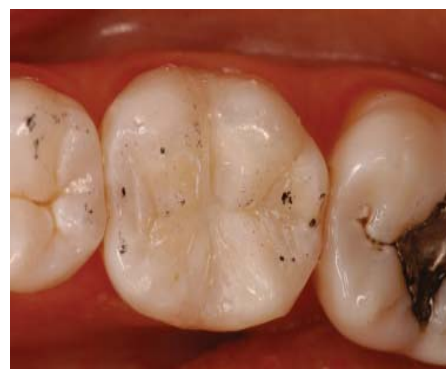
Figure 4. Final restoration after occlusal adjustment.

After checking occlusion with articulating paper and setting with a fine-grained diamond bur, the occlusal

contacts were adjusted using a polishing cup (Figure 4). After the end of the restorative procedures, the patient was instructed about what foods to avoid in the first 24 hours and was asked to return for evaluation. In the first two weeks, the patient reported a reduction in pain, but it did not disappear. A month later, pain was mild and only felt when the patient had cold or hot foods. At that time, the patient was examined, and occlusion was once again evaluated and adjusted, and the restoration underwent finishing and polishing. Monitoring after that revealed a reduction of symptoms. After seven years, the patient reported no pain. The clinical examination revealed that the restoration remained satisfactory and there were no stains or infiltrations signs (Figure 5). The monitoring radiograph ruled out periodontal lesions or periapical pathologies (Figure 6).

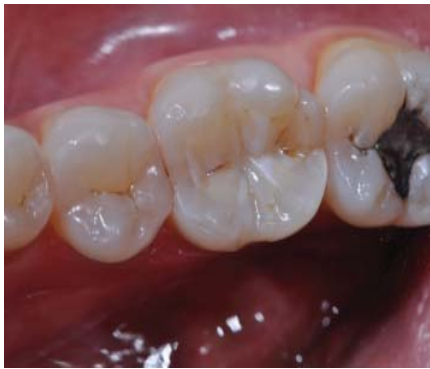
Figure 5. Restored tooth of a 7-year monitoring period.

Although the patient complained of pain, and especially thermal sensitivity, in the first month after the treatment, her pain had a low score on a visual analogue scale (VAS). Four years later, the patient had no complaints about mastication or thermal sensitivity. Despite of superficial staining there were no clinical or radiographic signs of marginal leakage, secondary carious lesions or pulp, periodontal or periapical changes.

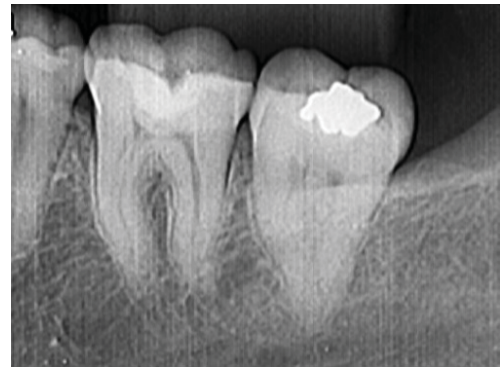
Figure 6. Radiograph of a 7-year monitoring period.
