INFLUENCE OF THE ASPECT RATIO ON SEISMIC PERFORMANCE OF ADOBE BUILDINGS

Danty Otero ^{1,2}

¹Facultad de Ingeniería Civil, Universidad Nacional de Ingeniería, Lima, Perú

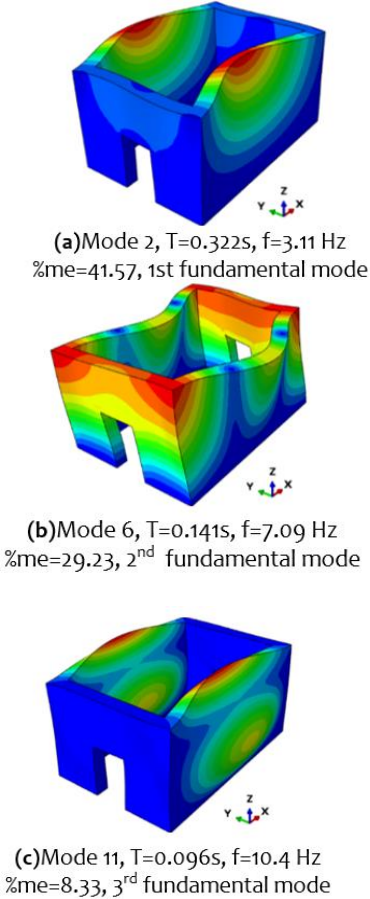
Fig. 13. Fundamental vibration modes in the direction of the Y axis. Model M2

Fig. 13 show the fundamental vibration modes in the direction of the Y axis. The first vibration mode involves 41.57% of the total mass.

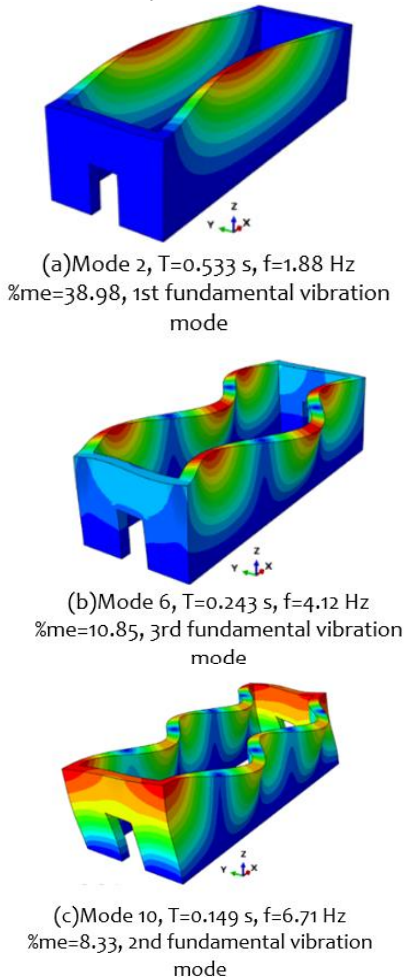
Fig. 18. Fundamental vibration modes in the direction of the Y axis. Model M2

Fig. 18 show the fundamental vibration modes in the direction of the Y axis. The first vibration mode involves 38.98% of the total mass.

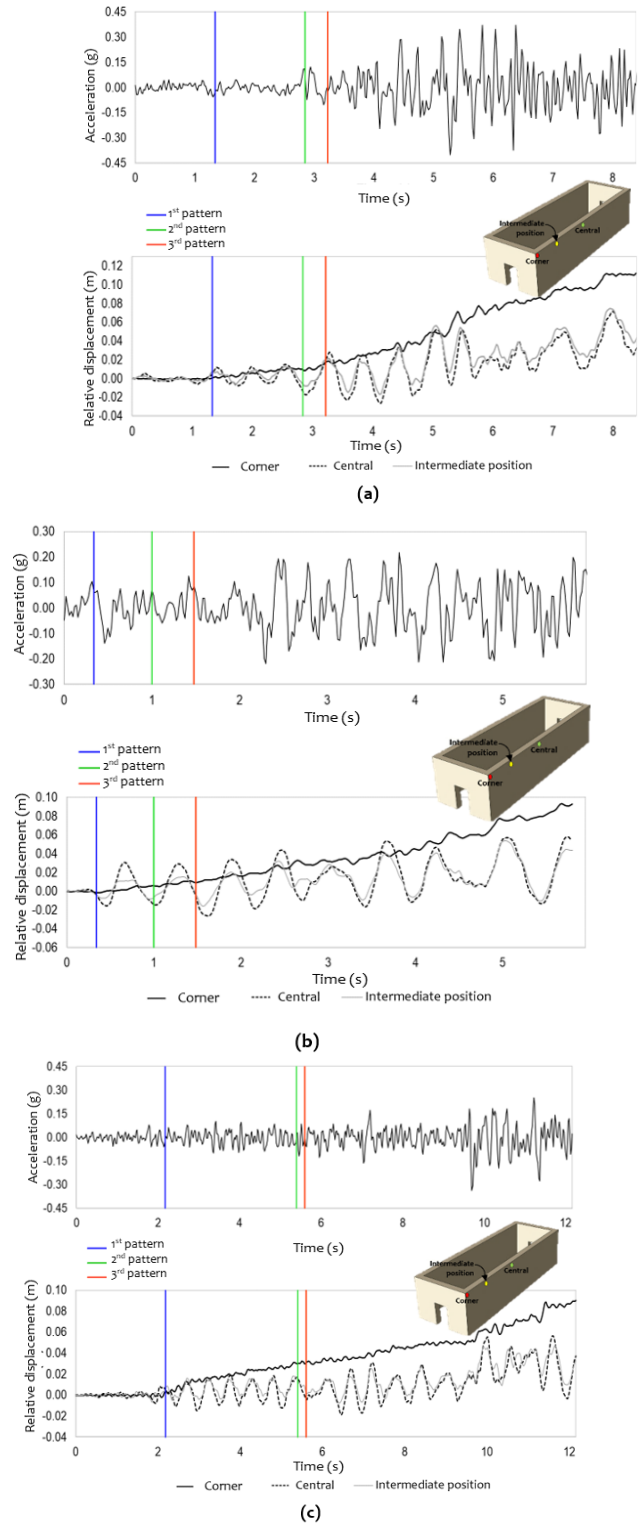
Fig. 22. Base acceleration and history of relative displacements of three nodes located at the top of the walls corresponding to the seismic of: (a) "Lima y Callao" (b) "Huaraz" (c) "Lima". Model M3

in the corner of the building, the second node located in the central part of the wall, and the third node at a horizontal distance slightly less than wall height (near the place where the third cracking pattern is formed). The blue, green, and red vertical lines are the beginning of the first, second, and third cracking patterns, respectively.

Fig. 22 show the history of relative displacements of three nodes located at the top of the longitudinal wall with respect to the base; the first node located

In the previous figures, it can be observed that the first pattern (vertical corner cracks) appears for ground accelerations close to 0.08 G, and that the third cracking pattern occurs for accelerations close to 0.14 G.

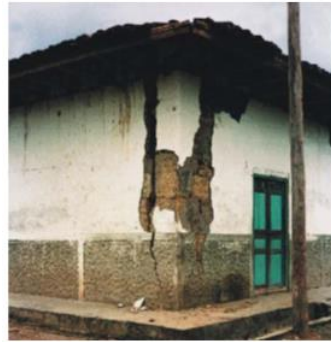
Fig. 279. Comparison of damages obtained in numerical simulations with real buildings (a) Plastic deformations in the numerical model (b) Damage to buildings due to past earthquakes by J. Kuroiwa [8]

As observed in the cracking process, extensive vertical cracks form in the corners of the building, which could cause the failure of the walls ;Error! No se encuentra el origen de la referencia.(Fig. 29).

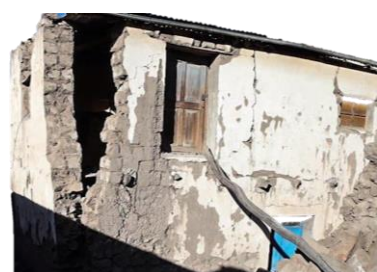
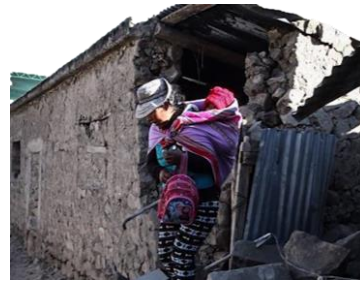
Fig.32. Collapse in corners of a building (a) Plastic deformations in the numerical models (b) Andina Peruvian news agency [1]

Vertical cracks appear at the corners of the wall causing the adobe blocks in that area to break and fall (See Fig. 32).
