Update on the occurrence of the soil liquefaction phenomenon in peru
Actualización de la ocurrencia del fenómeno de licuación de suelos en el Perú

Jorge Alva-Hurtado¹0000-0001-9107-2218

Carmen Ortiz-Salas^{1*}0000-0002-7643-6711

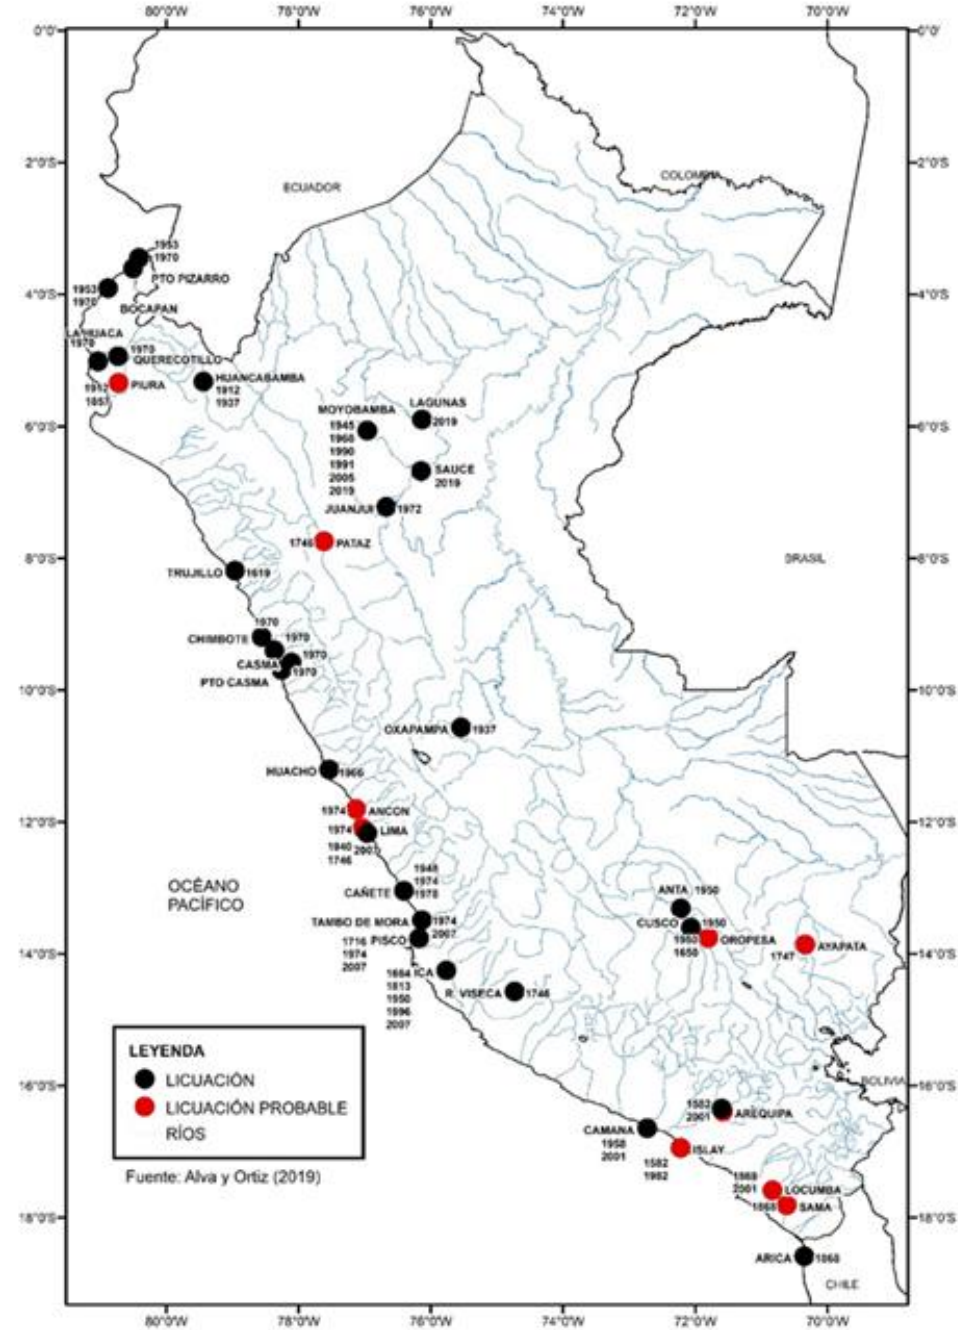
Fig. 15. Map of Soil Liquefaction areas of Peru

Finally, a map illustrating the soil liquefaction areas in Peru (see Fig. 15) was prepared based on the information. 14 collected.
